URBANA TRAFFIC SIGNAL ASSET MANAGEMENT PLAN

City of Urbana, Illinois

March 10, 2023

Lochmueller Project Number: 421-1002-01T

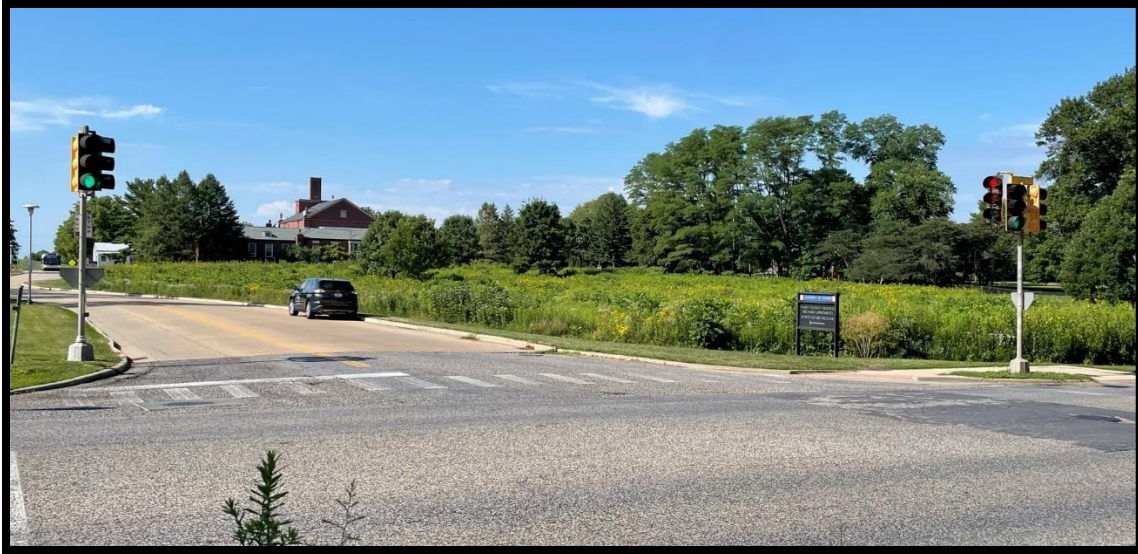
Figure 2. Signal Heads at Florida Ave and Orchard St.

In addition to improving visibility of all signal heads at this intersection and ensuring signal posts get moved further away from the faces of curb, another benefit of installing mast arms would be to allow for future protected/permitted phasing (i.e., use of 4-section flashing yellow arrow signal heads or 5-section R-Y-G-YL-L signal heads) for left-turn movements along Florida Avenue. If the City ever desired to implement protected/permitted left-turn phasing at this intersection, mast arms would need to be present, to allow for the minimum number of signal heads that would be required (e.g., one signal head for the left-turn movement + two signal heads for the adjacent through movement) by the MUTCD. Should the City desire to implement City-wide preemption system in the future, having mast arms in place would also allow for optimal overhead placement of preemption related equipment.

If the City decides to install new mast arms at this intersection, it is recommended that all existing signal related equipment be replaced. For the associated signal related work to remove all existing equipment and implement new mast arms at this intersection, a budgetary level estimate of construction cost would be approximately \$175,000. This cost would not include any curb ramp and sidewalk related work. It would behoove the City, though, to also include the implementation of recommended curb ramp and sidewalk facility upgrades at this intersection along with any signal modification work, given that three of the four quadrants at this intersection do not have compliant curb ramp facilities. A budgetary level estimate of construction cost for reconstructing non-compliant curb ramps and sidewalk panels at this intersection would be approximately \$45,000.
